| SAIPEM LTD | | | | | | COMPANY ACCEPTANCE OF FINAL VERSION | | |
|---|---|---|---|---|---|--|---|---|
| ENVIRONMENTAL REPORTING: PHYSICAL LOSSES AND PHYSICAL DISTURBANCES OF THE SEABED – DENMARK | | | | | | Contractor | | |
| Area No. | Area Description | PL1-SAI-12-Z02-RA-00003-EN | | | | | | |

The purpose of this document is to present the monitoring results to the Danish Energy Agency.

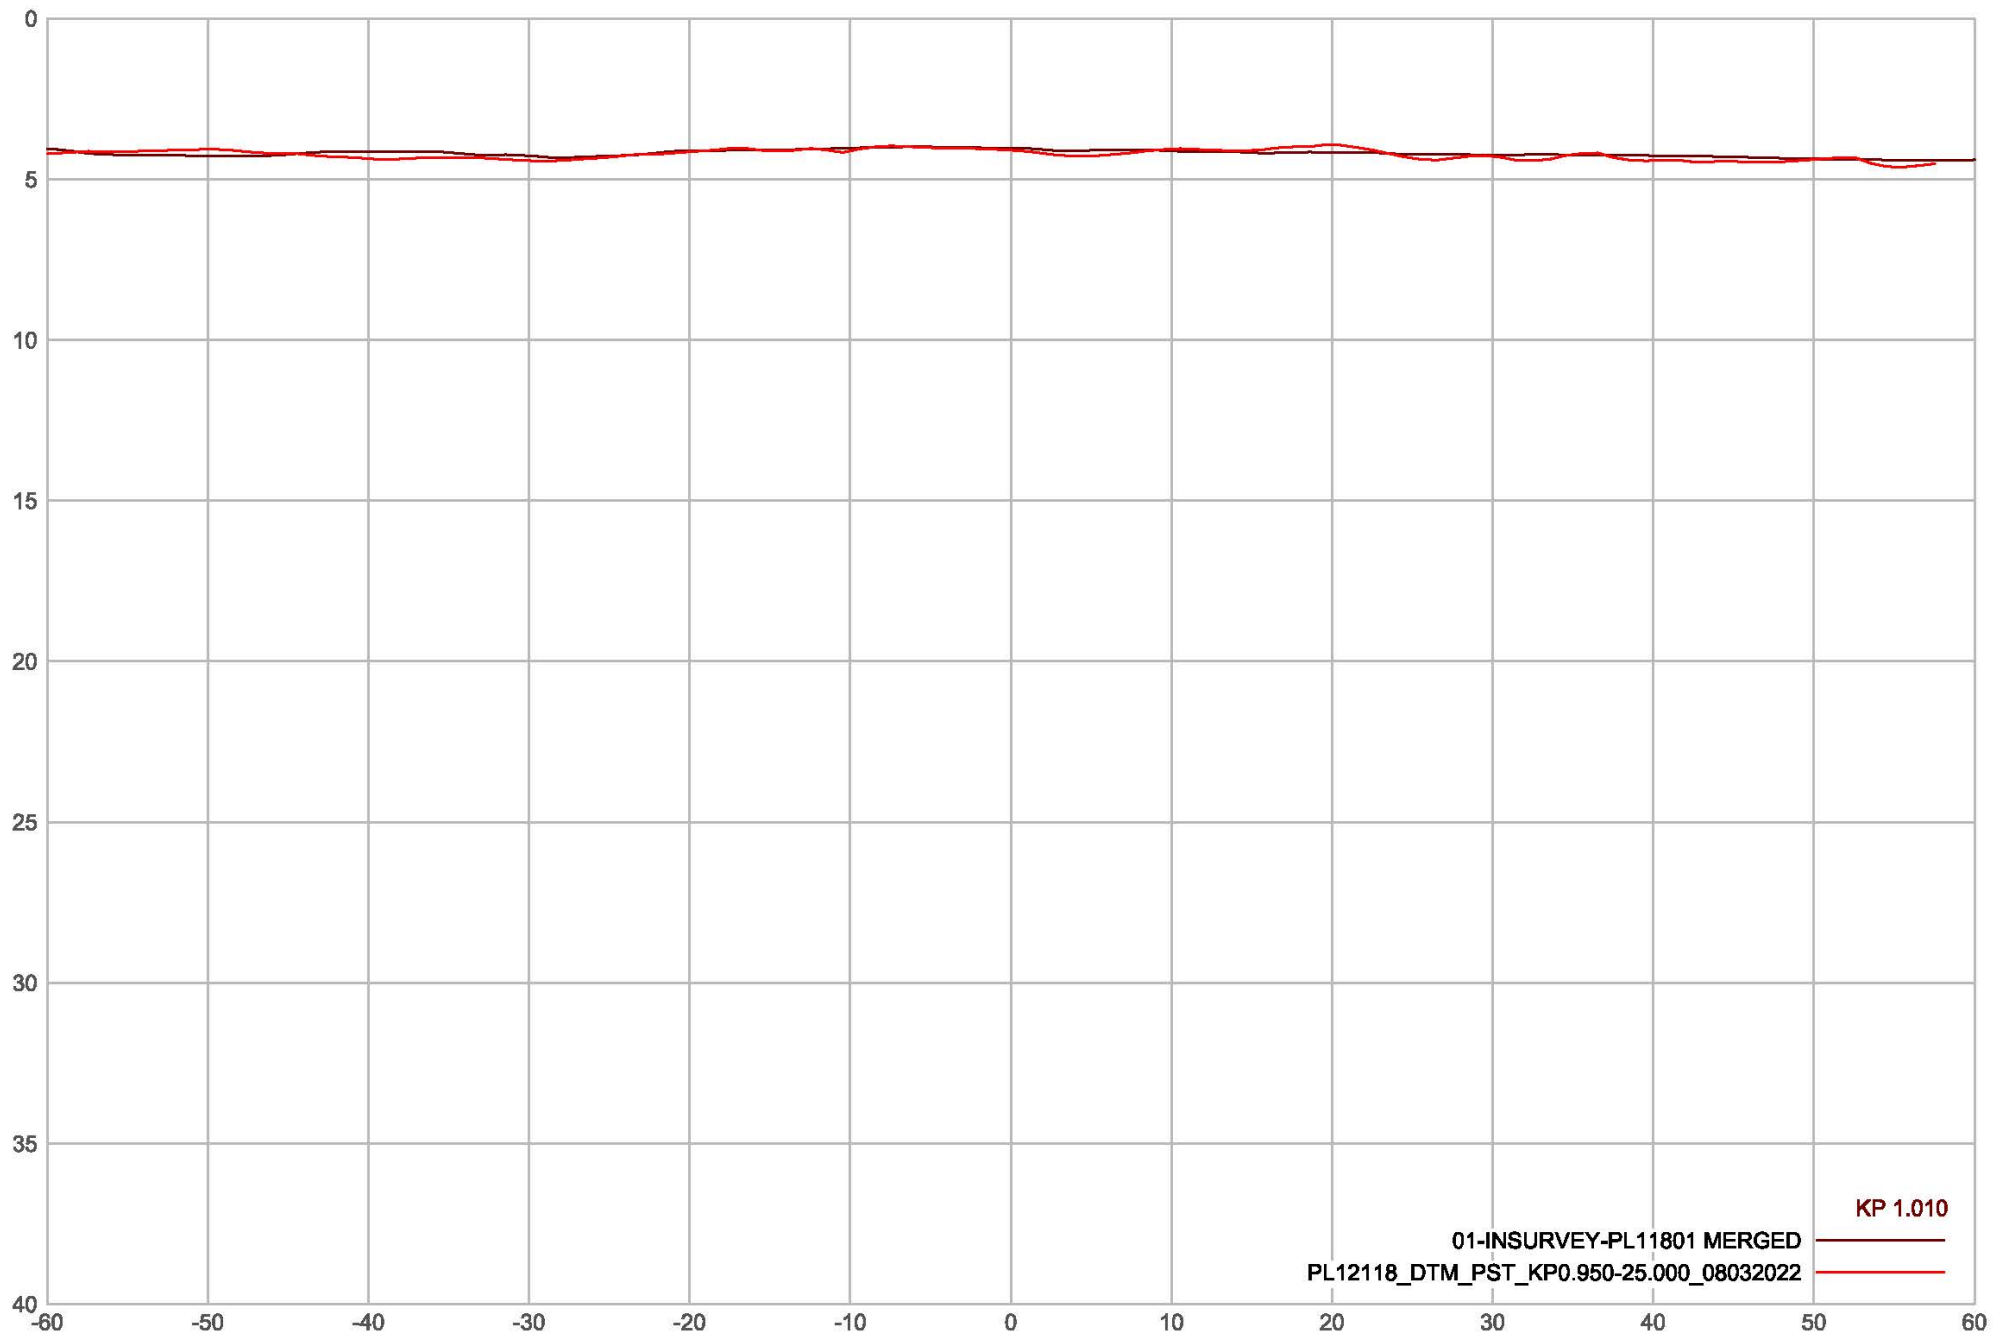
Figure 4-1: Cross-Sectional Profile at KP1.010

Minimal disturbance of the seabed is observed each side of the trench because all excavated material was placed at two (2) temporary spoil storage areas – located in water depths greater than seven (7) metres. The use of temporary spoil storage areas was part of the measures employed to minimise disturbance of the eel grass meadows in the vicinity of the micro-tunnel exit pit.

The cross-sectional profile illustrated in Figure 4-1 indicates very close alignment between the pre-dredging and post-backfilling seabed profiles. The pre-dredging seabed profile is indicated with a black line and the post-backfilled seabed profile is indicated with a red line.

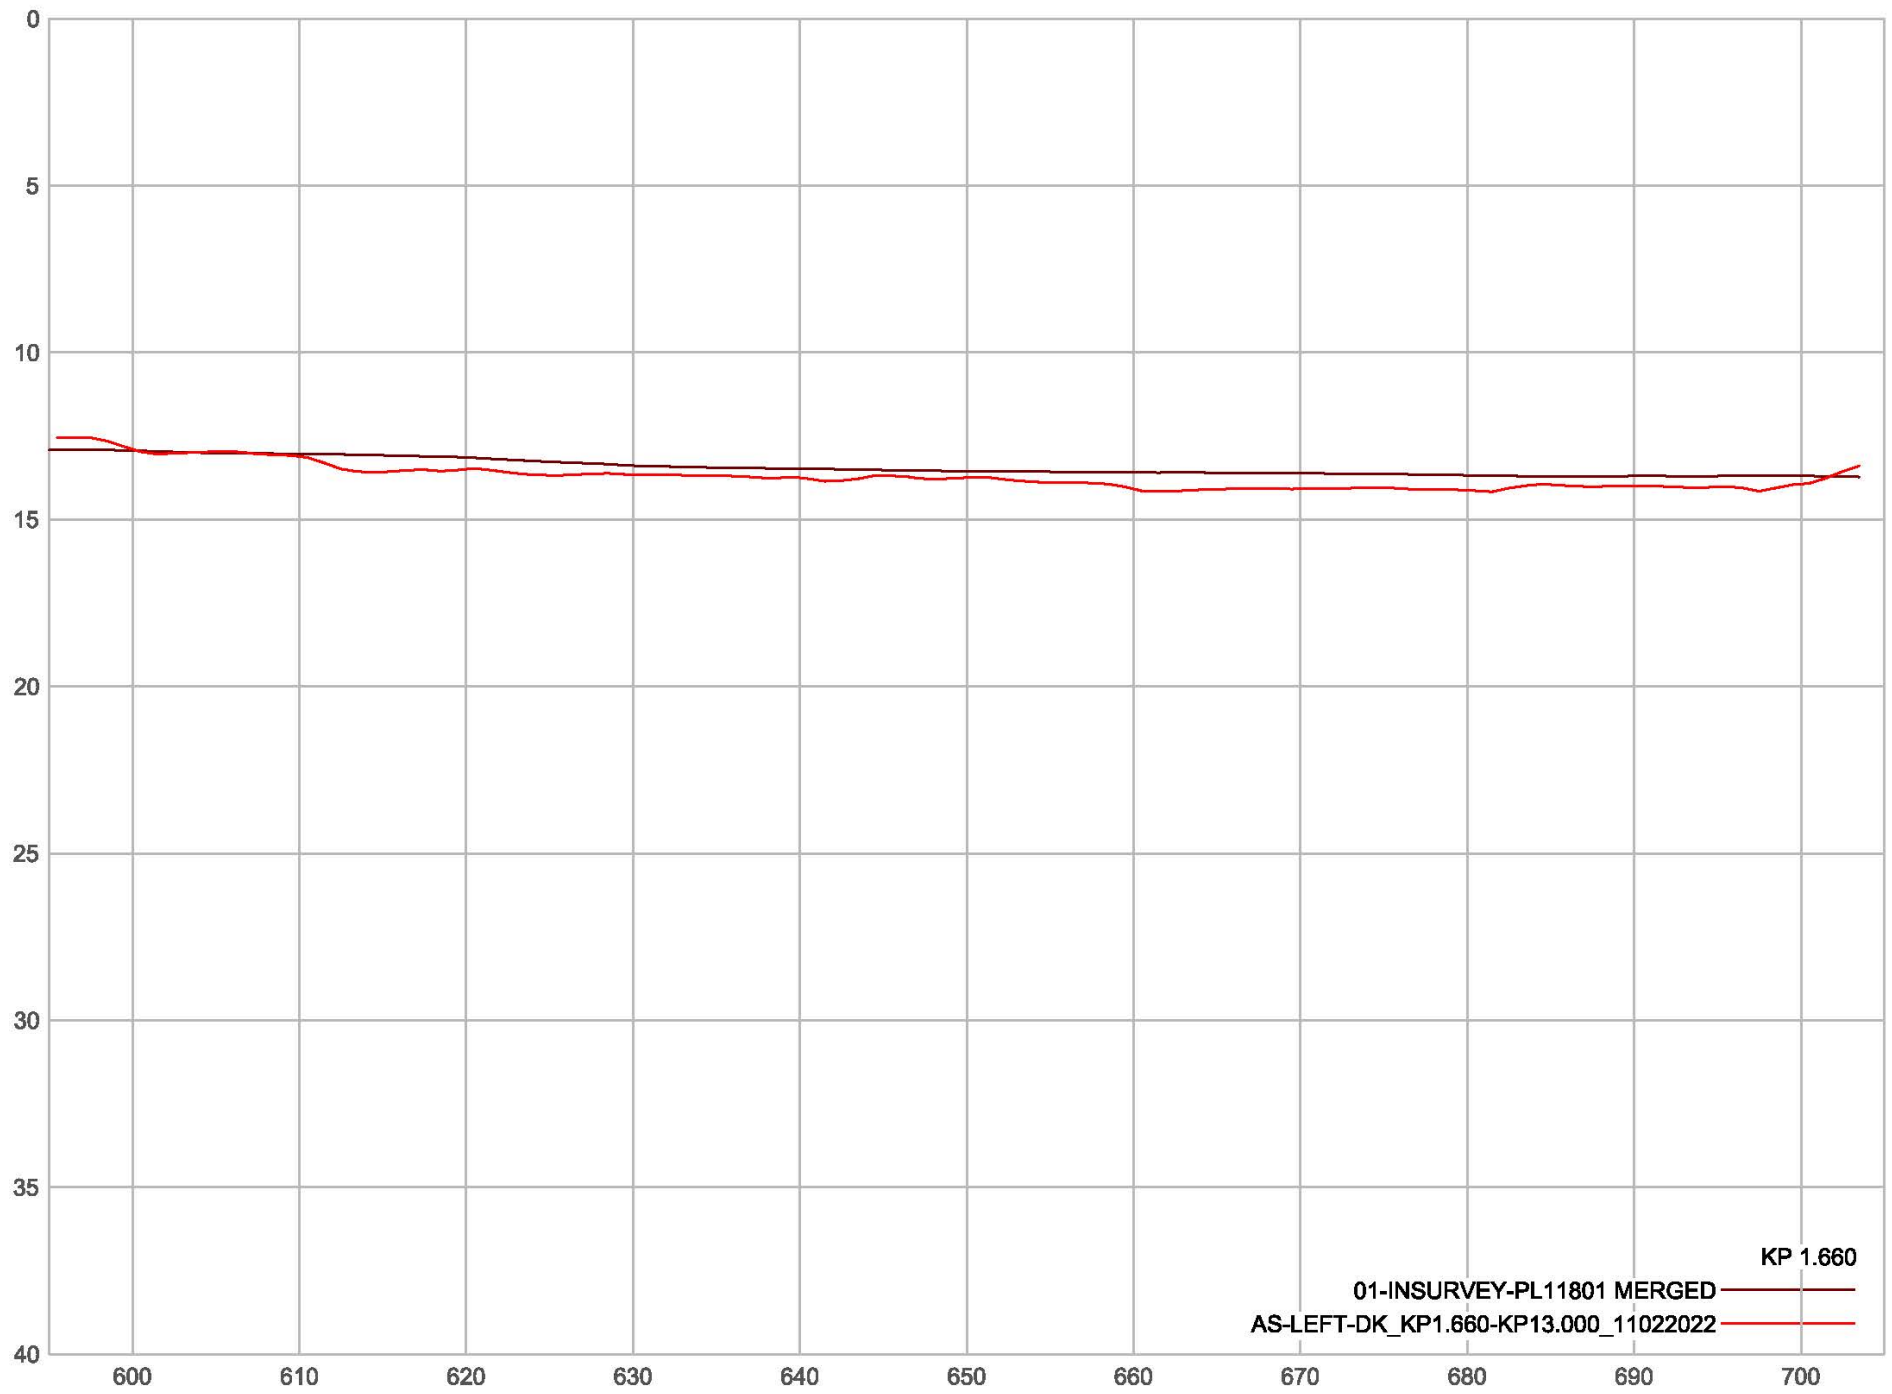
Figure 4-2: Cross-Sectional Profile at KP1.660

The cross sectional profile is illustrated in Figure 4-2. The as-found seabed profile is indicated with a black line and the as-left seabed profile is indicated with a red line. Review of the profiles indicate that some of the original seabed may have been excavated whilst recovering the previously dumped spoil for the post-lay backfilling operation. This is to be expected considering the capability and accuracy of the equipment employed. It is also observed that the seabed elevation at the edges of the spoil storage area recorded in the as-left survey are greater than those obtained in the as-found survey. It is worth highlighting that sediment transport arising from environmental actions (i.e. from waves and currents) was observed during the period between pre-lay dredging and post-lay backfilling. This is likely to have resulted in some material within the spoil storage area migrating outside its boundary.

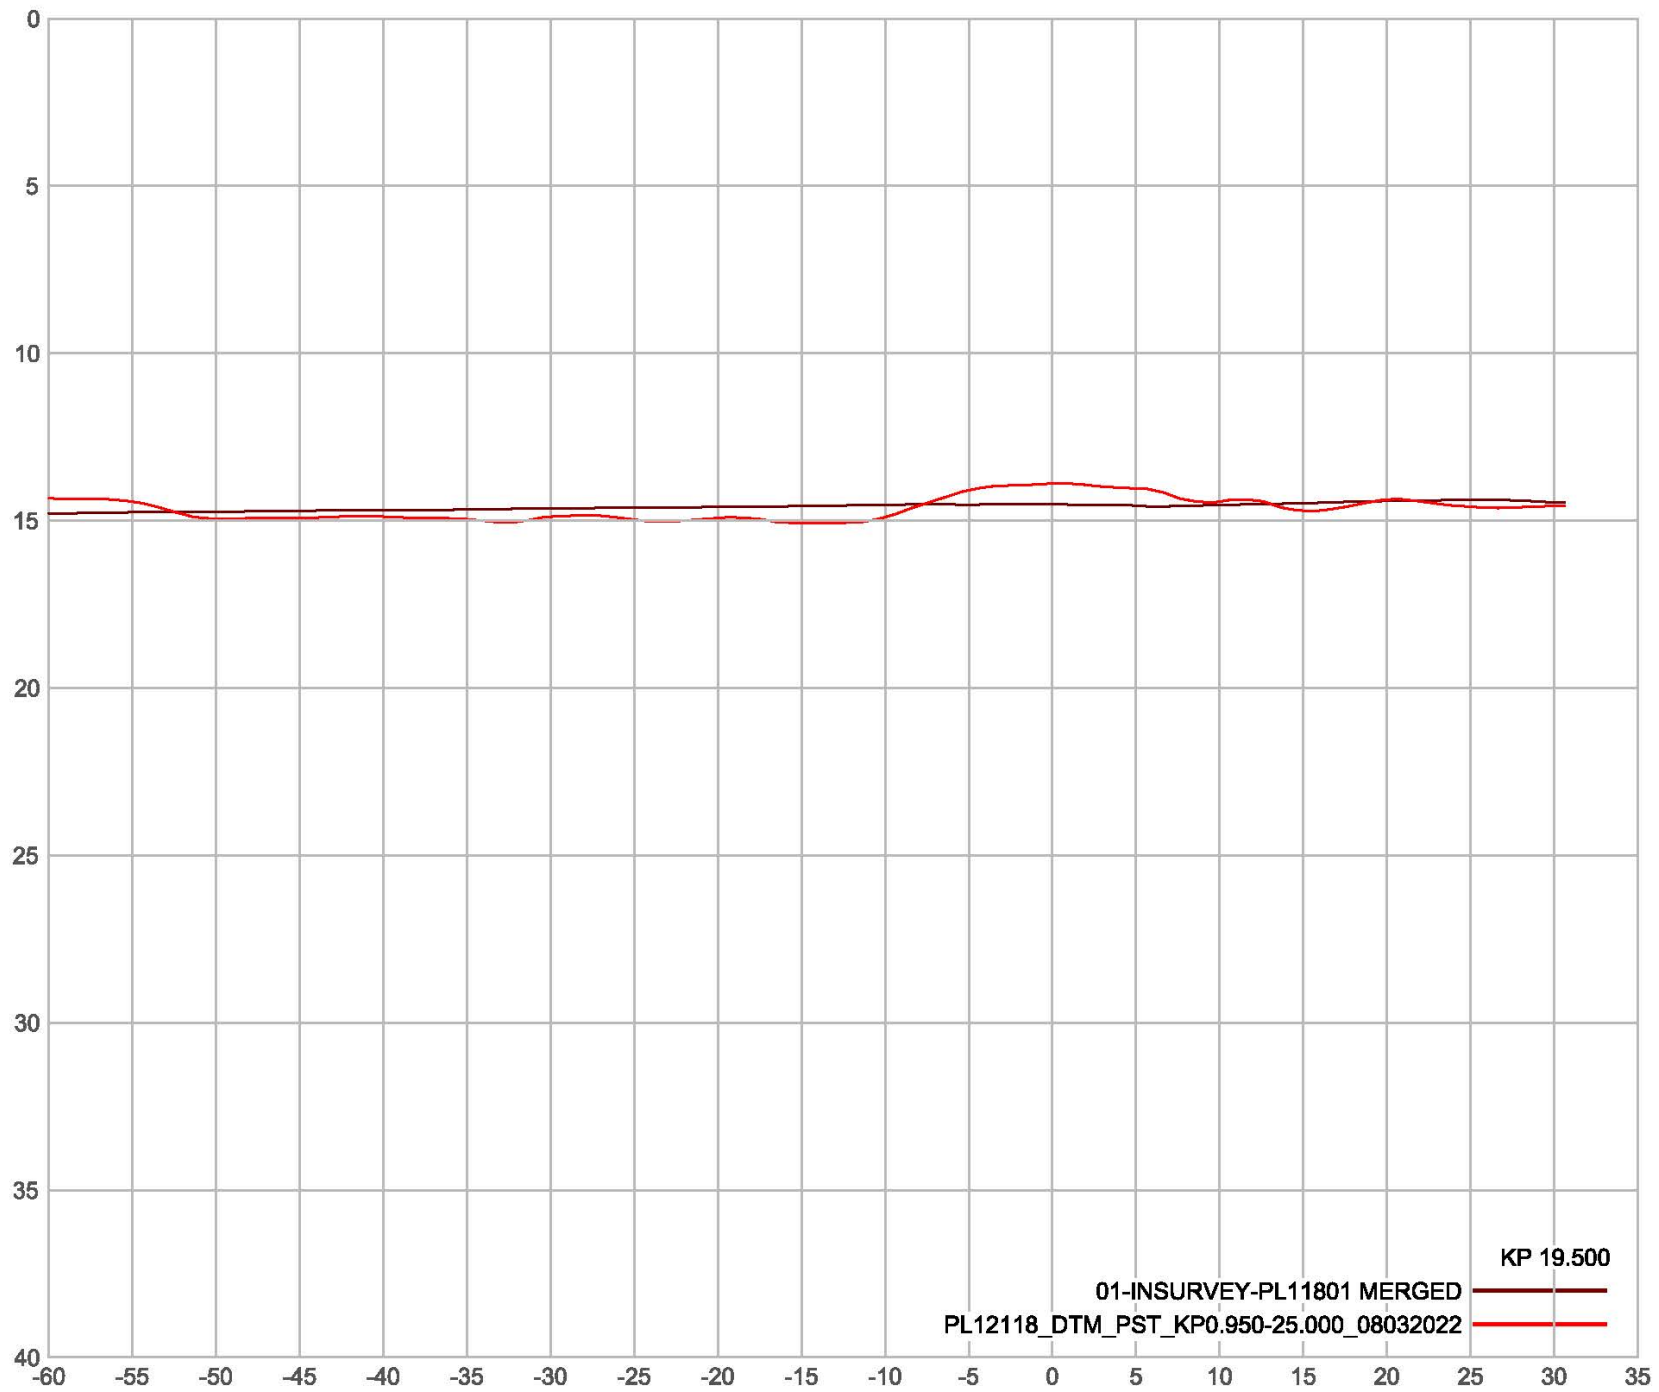
Figure 4-5: Cross Sectional Profile at KP19.500

The cross sectional profile is illustrated in Figure 4-5. The pre-dredging seabed profile is indicated with a black line and the as-left seabed profile is indicated with a red line. Review of the profiles indicate that the as-left seabed elevation is greater than the pre-dredging elevation in the

vicinity of the pipeline centre-line (0m on the horizontal axis) – in accordance with the design requirements. The as-left seabed elevation is marginally lower than the pre-dredging elevation across approximately 45m of the cross section (-52m to -7m on the horizontal axis).

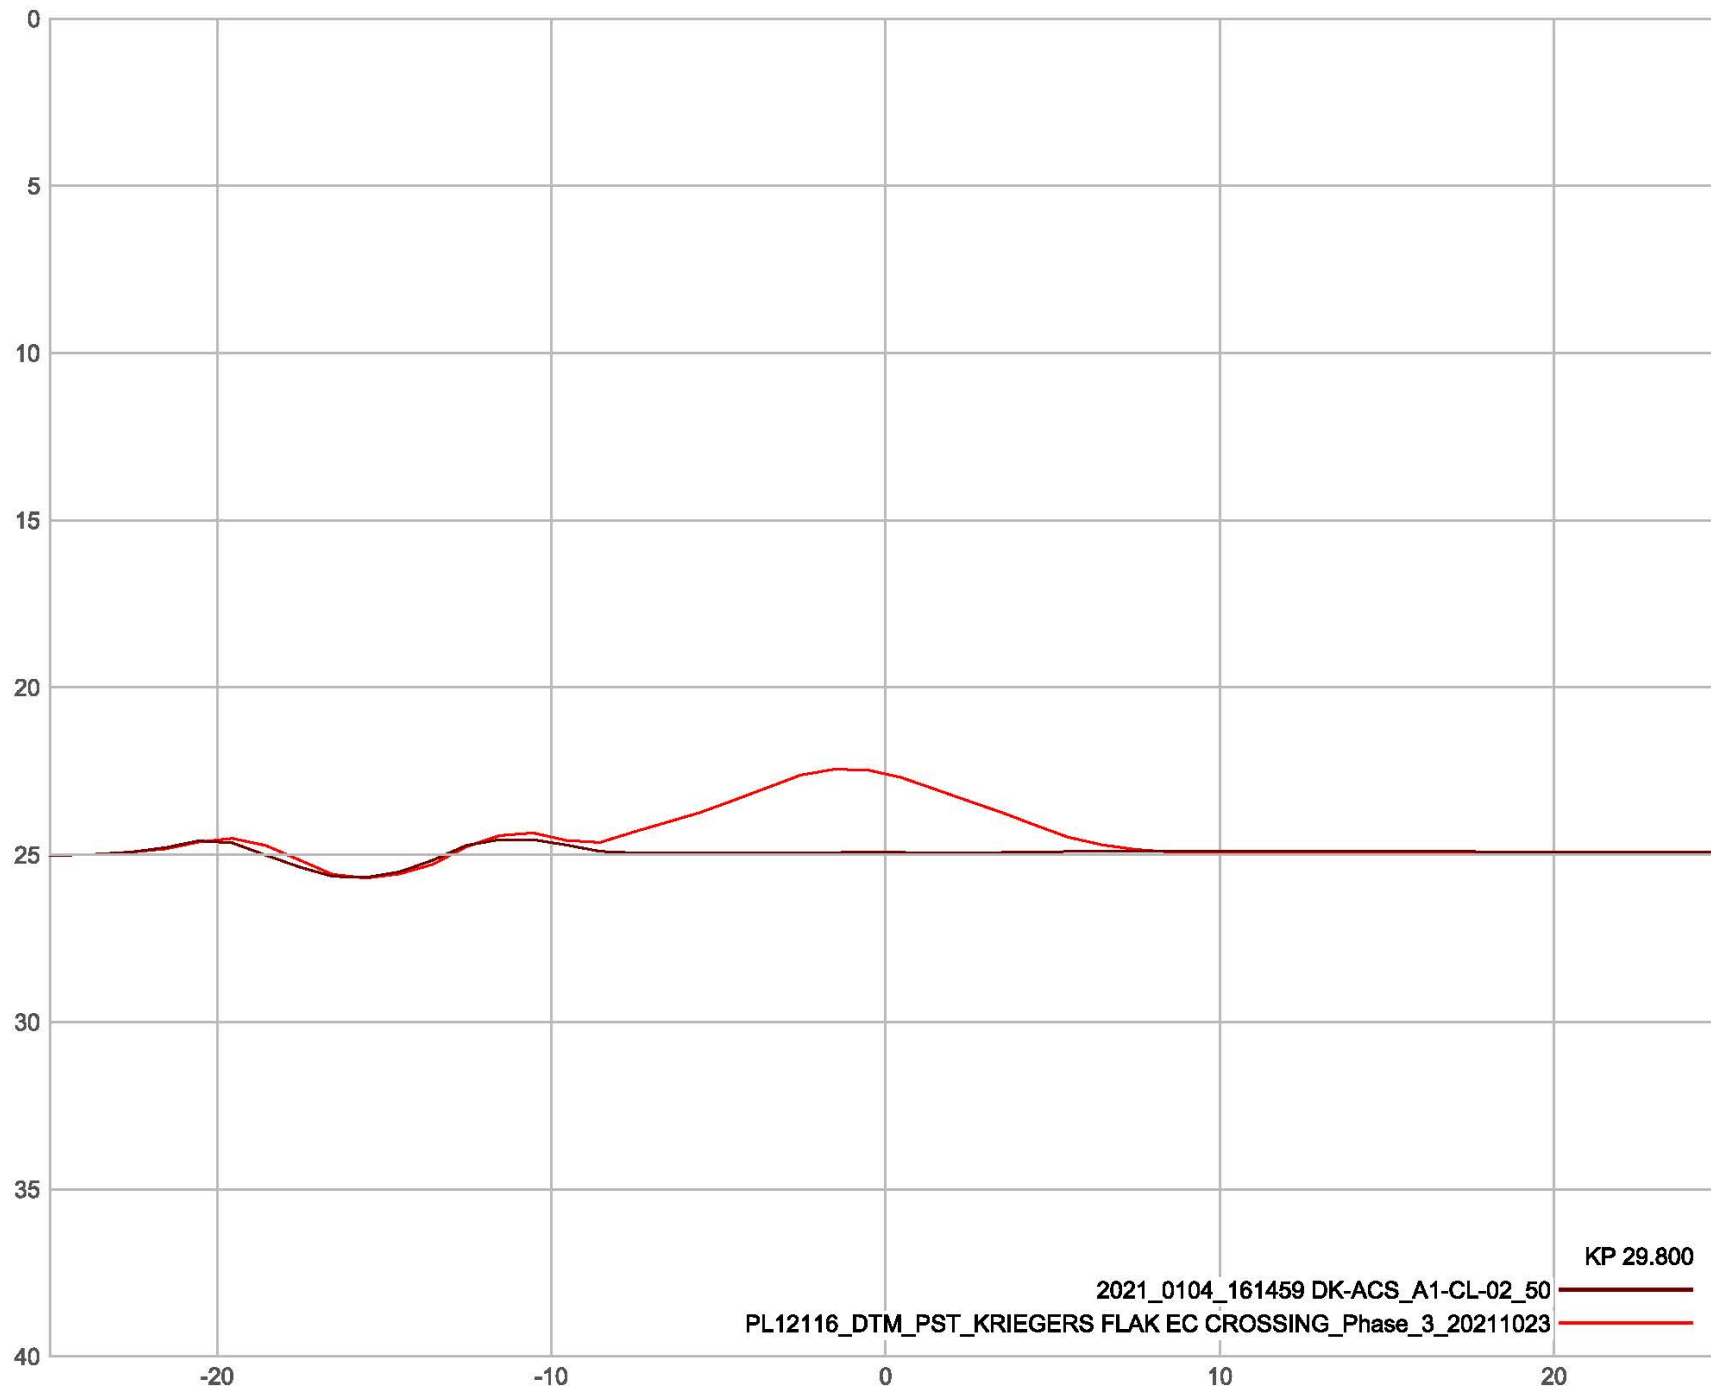
Figure 4-7: Cross Sectional profile at KP29.800

The cross sectional profile is illustrated in Figure 4-7. The as-found seabed profile is indicated with a black line and the post-rock installation seabed profile is indicated with a red line. It can be observed that the rock berm, which extends each side of the pipeline centreline (0m on horizontal axis), is approximately 16m in width and rises approximately 2.5m above the original seabed elevation.

The existing trenched and buried cable, converging towards the crossing location, is indicated by the "U" shaped configuration (-22m to -8m on the horizontal axis).

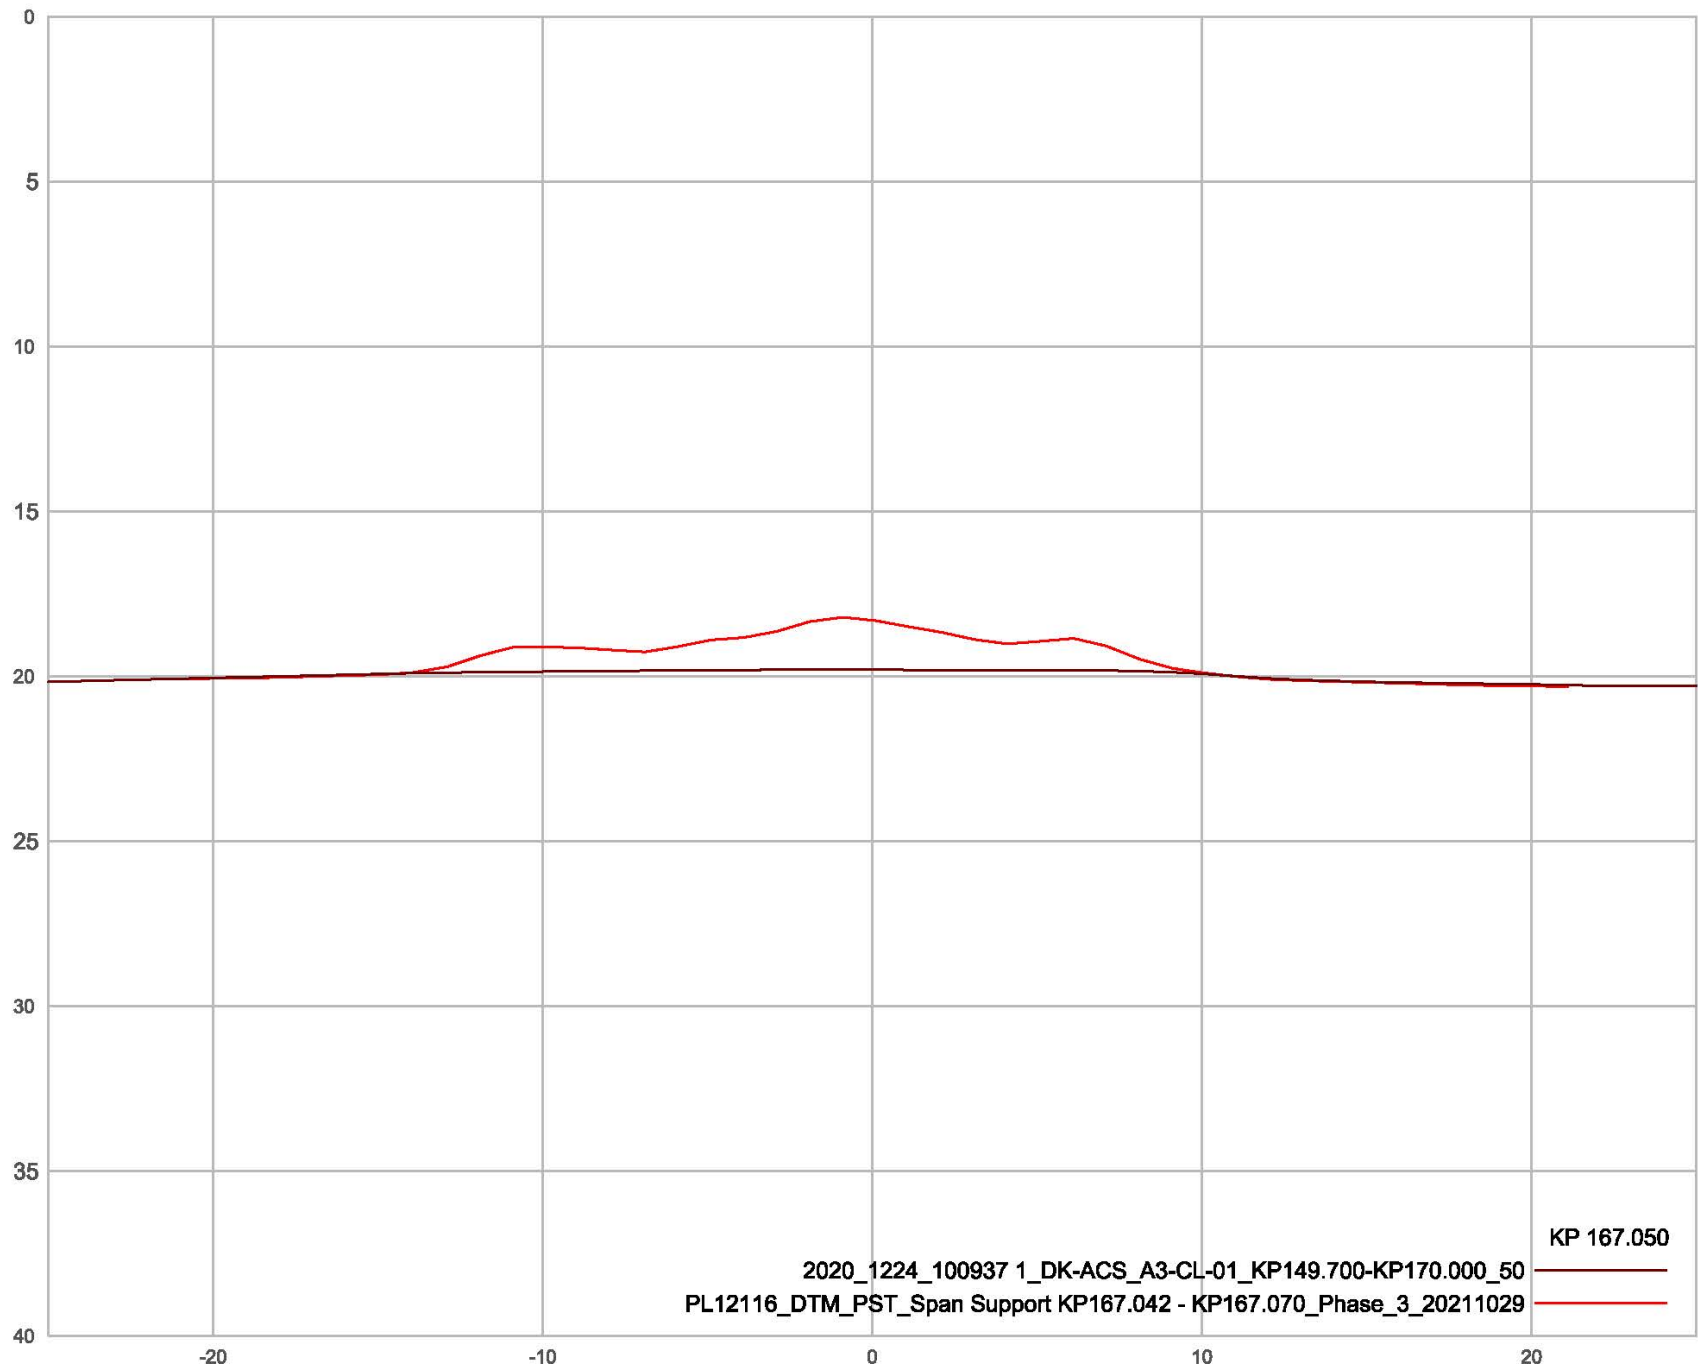
Figure 4-8: Cross Sectional Profile at KP167.050

The cross sectional profile is illustrated in Figure 4-8. The as-found seabed profile is indicated with a black line and the post-rock installation seabed profile is indicated with a red line. It can be observed that the rock berm, which extends each side of the pipeline centreline (0m on horizontal axis), is approximately 25m in width and rises approximately 2m above the original seabed elevation.

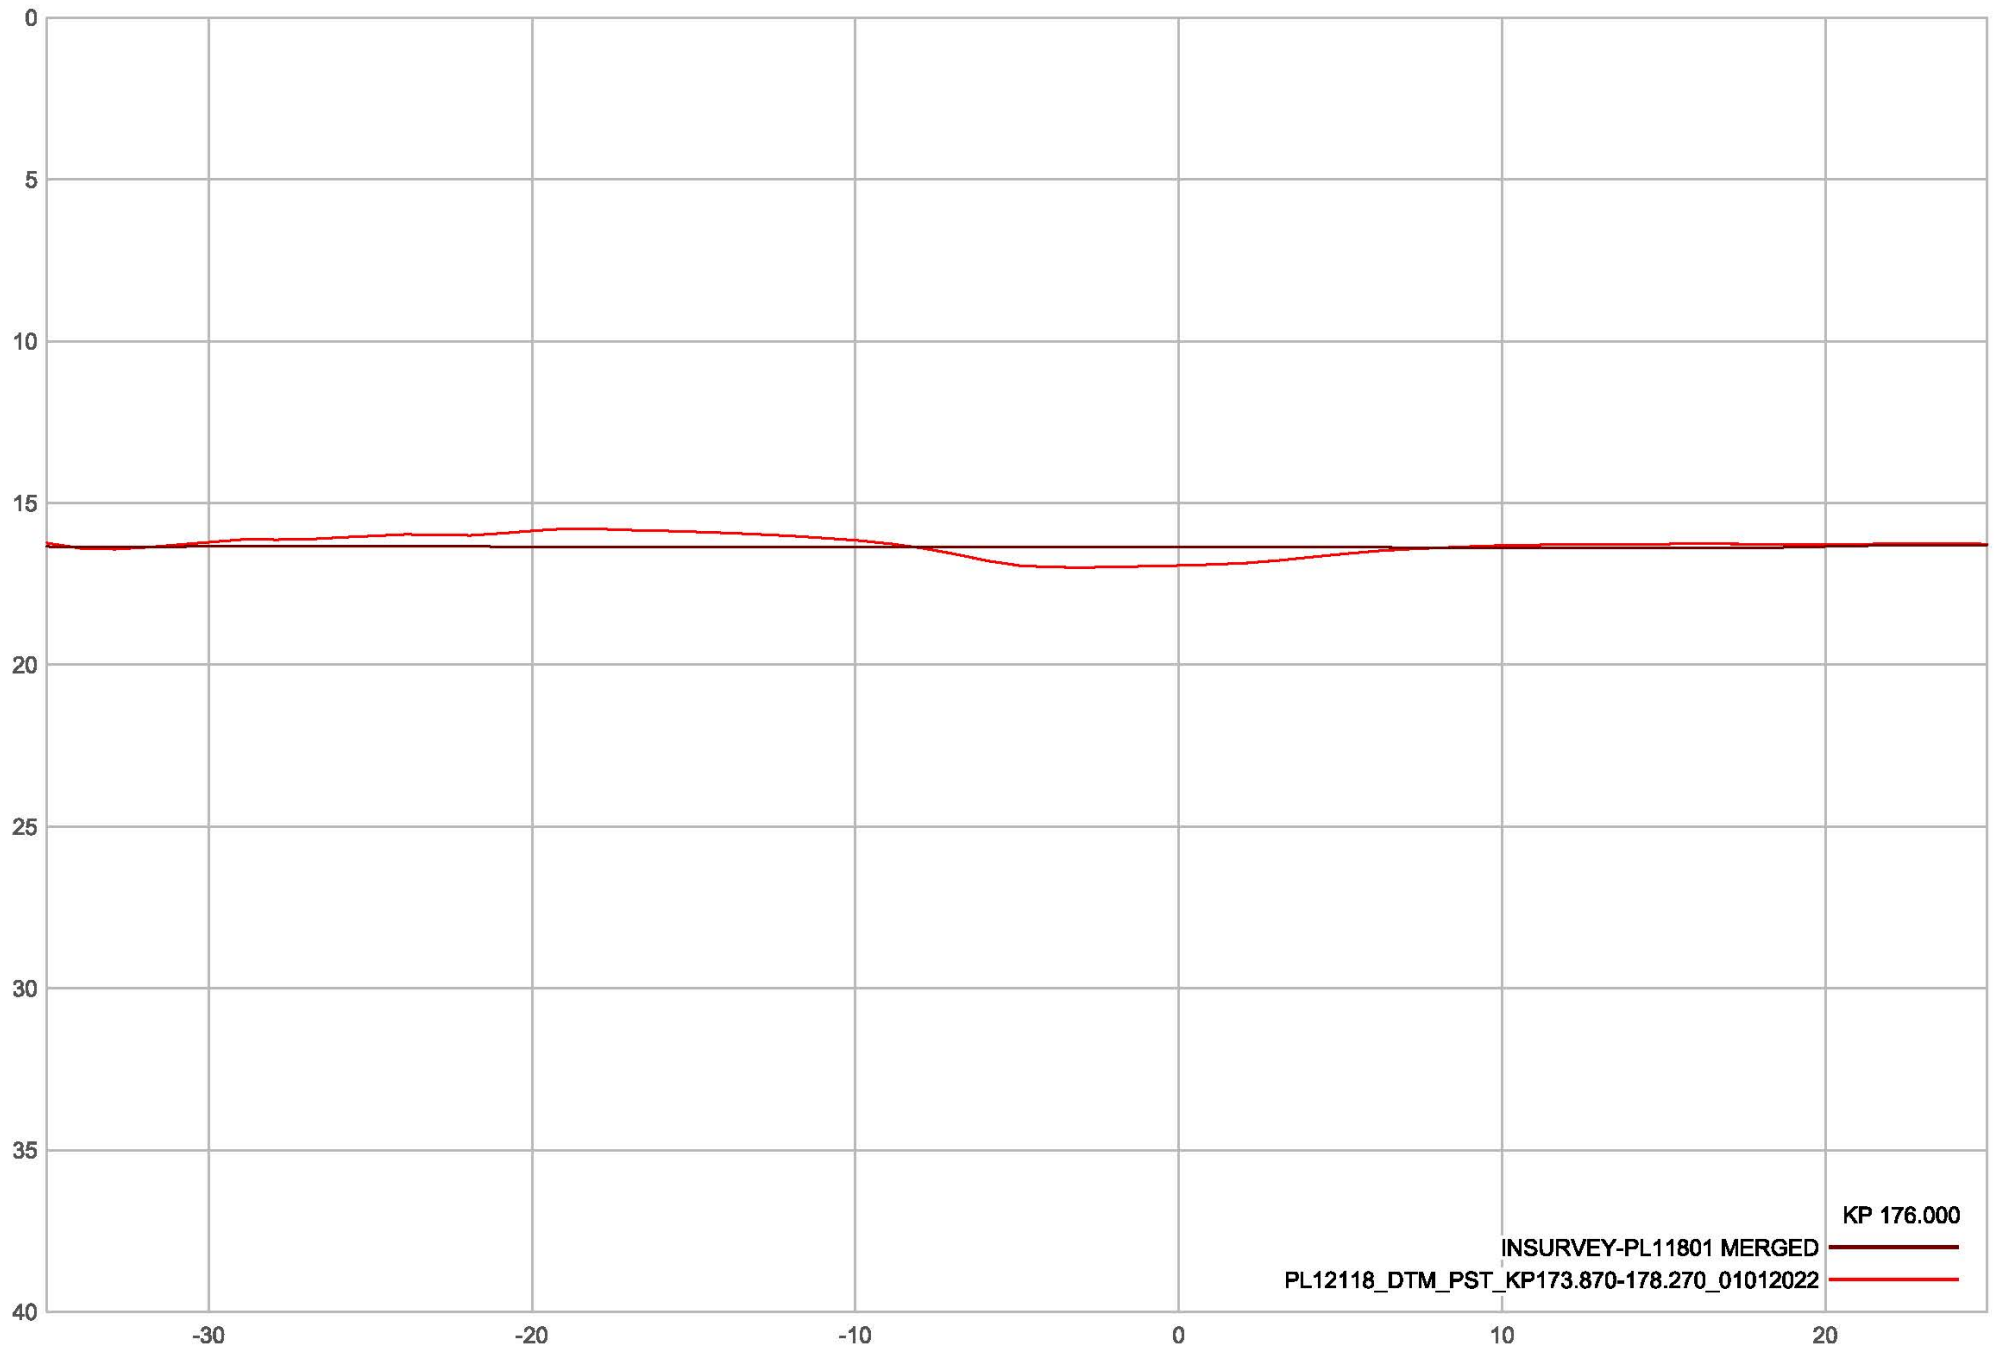
Figure 4-10: Cross Sectional Profile at KP176.000

The cross sectional profile is illustrated in Figure 4-10. The pre-dredging seabed profile is indicated with a black line and the post-backfill seabed profile is indicated with a red line. Review of the profiles indicate that the post-backfill seabed elevation is marginally lower than the pre-dredging elevation at the location of the pipeline trench (-8m to 7m on the horizontal axis). The post-backfill seabed elevation is marginally higher than the pre-dredging elevation at the location of the spoil heap (-31m to -8m on the horizontal axis).

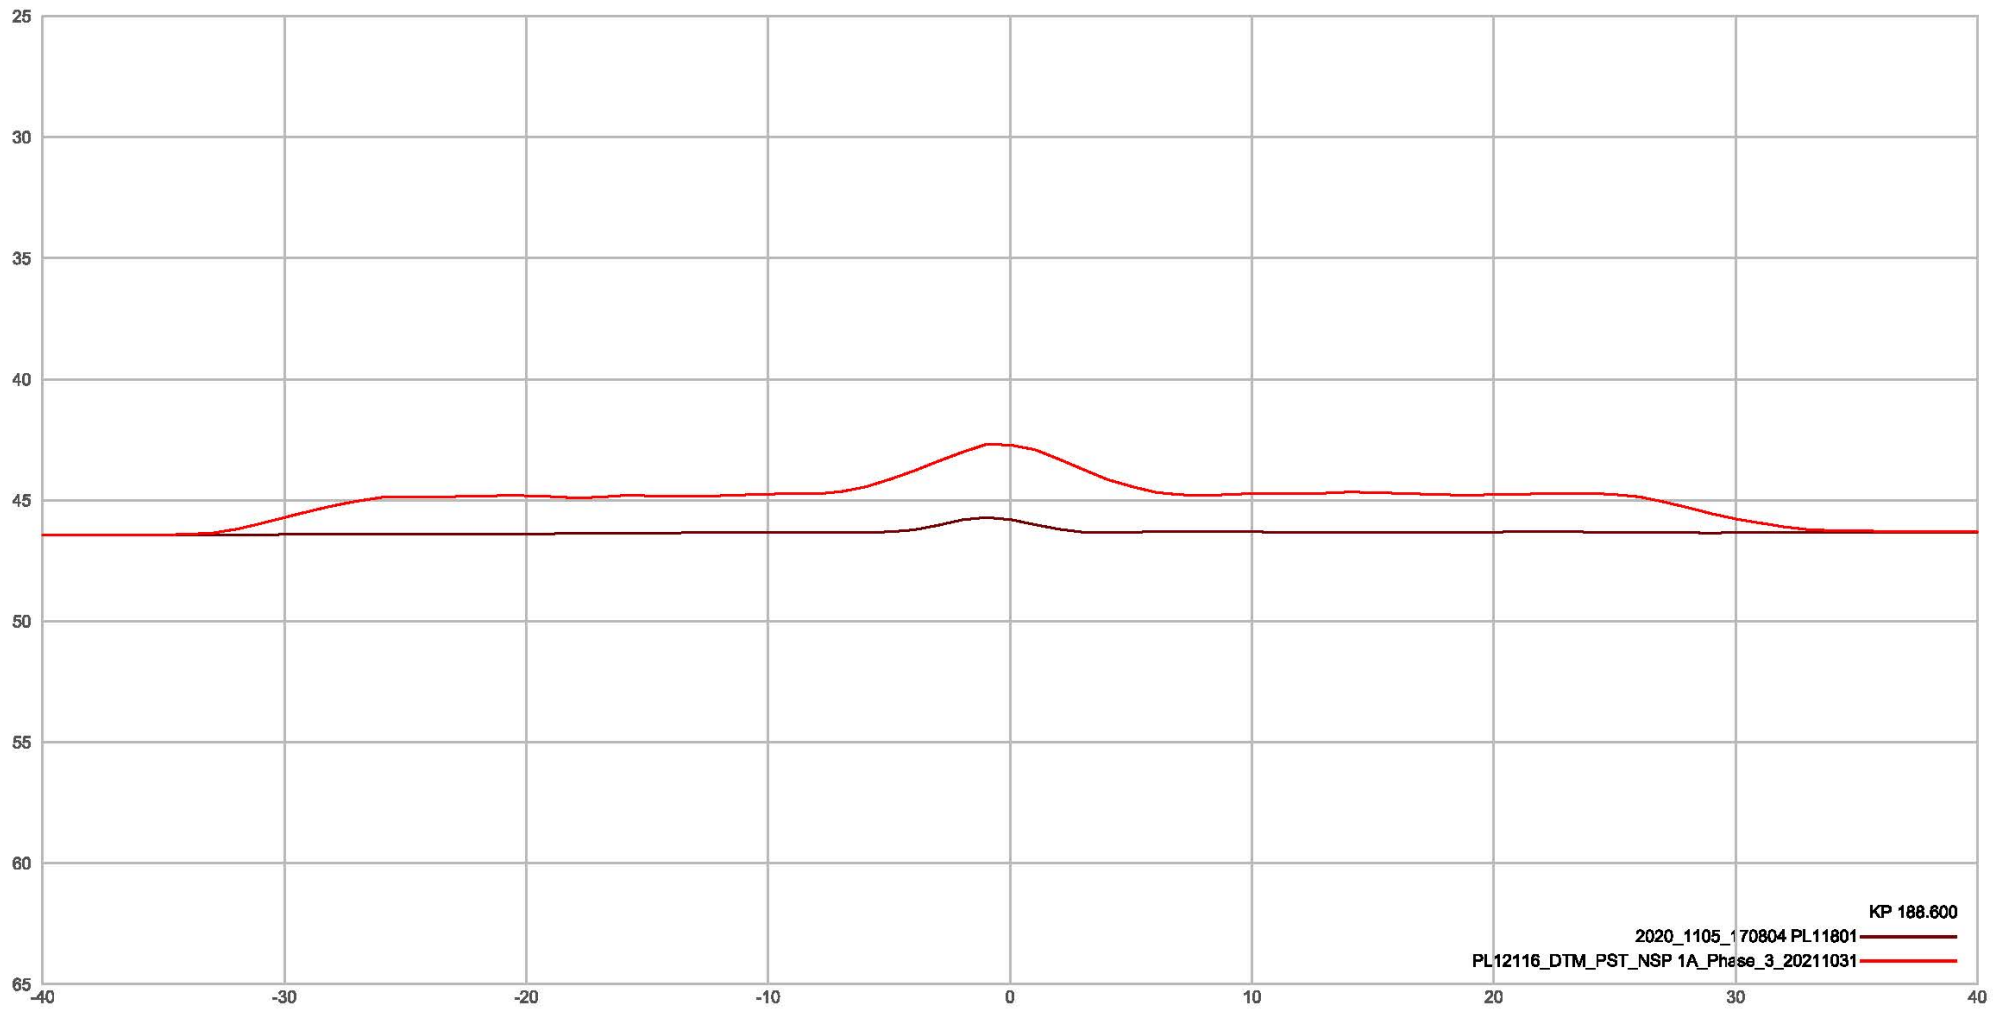
Figure 4-13: Cross Sectional Profile at KP188.600

The cross sectional profile is illustrated in Figure 4-13. The as-found seabed profile is indicated with a black line and the post-rock installation seabed profile is indicated with a red line. It can be observed that the rock berm, which extends each side of the pipeline centreline (0m on horizontal axis), is approximately 70m in width and rises approximately 3.5m above the natural seabed elevation at its highest point.

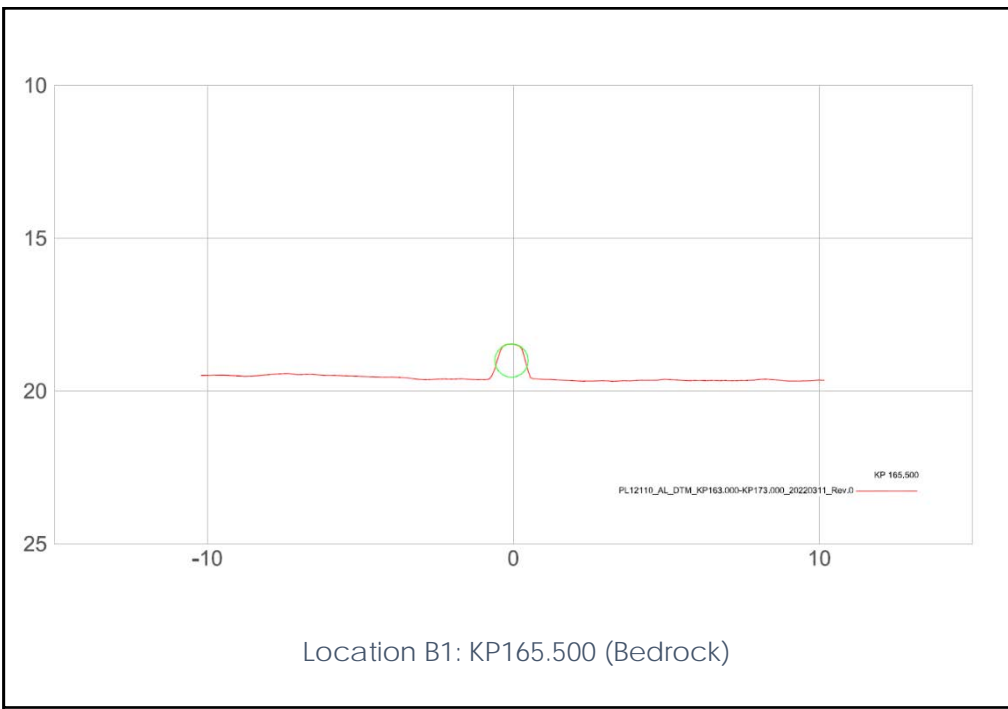
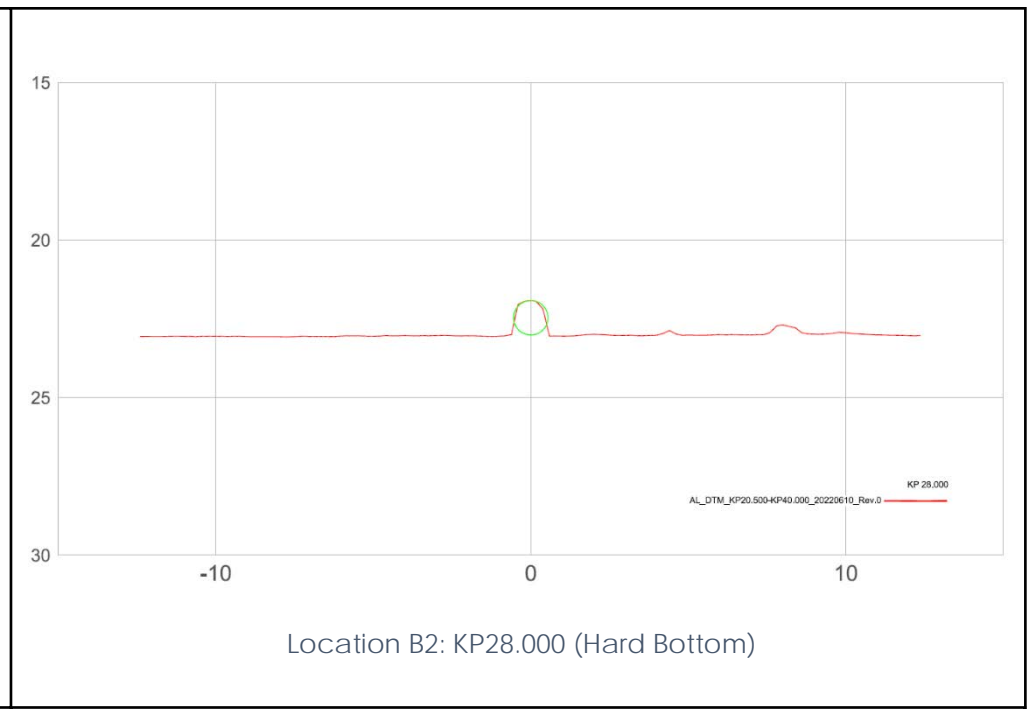
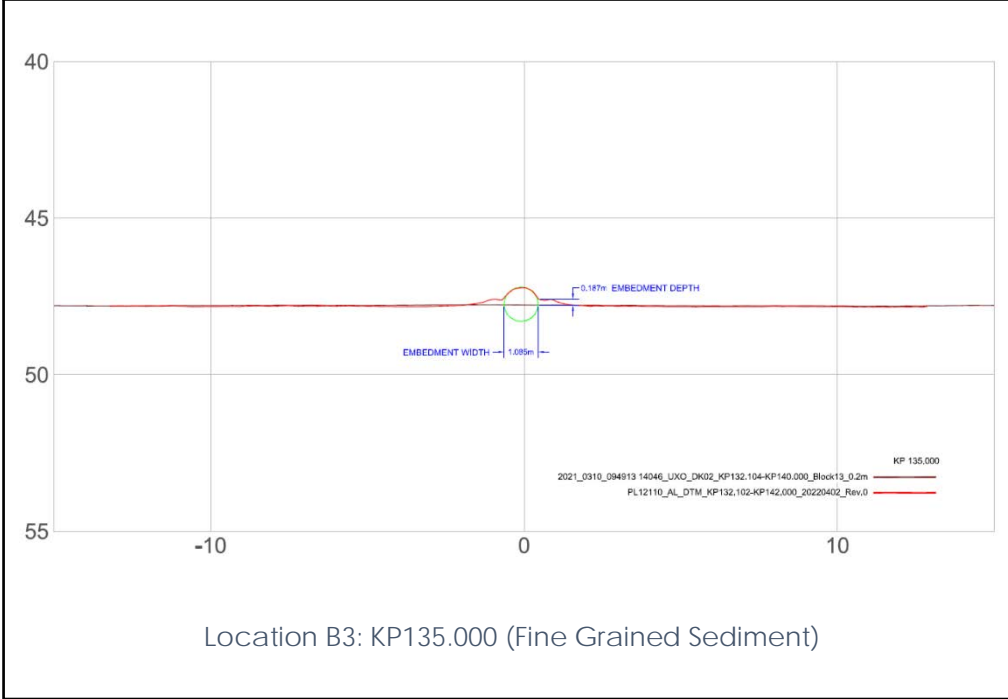
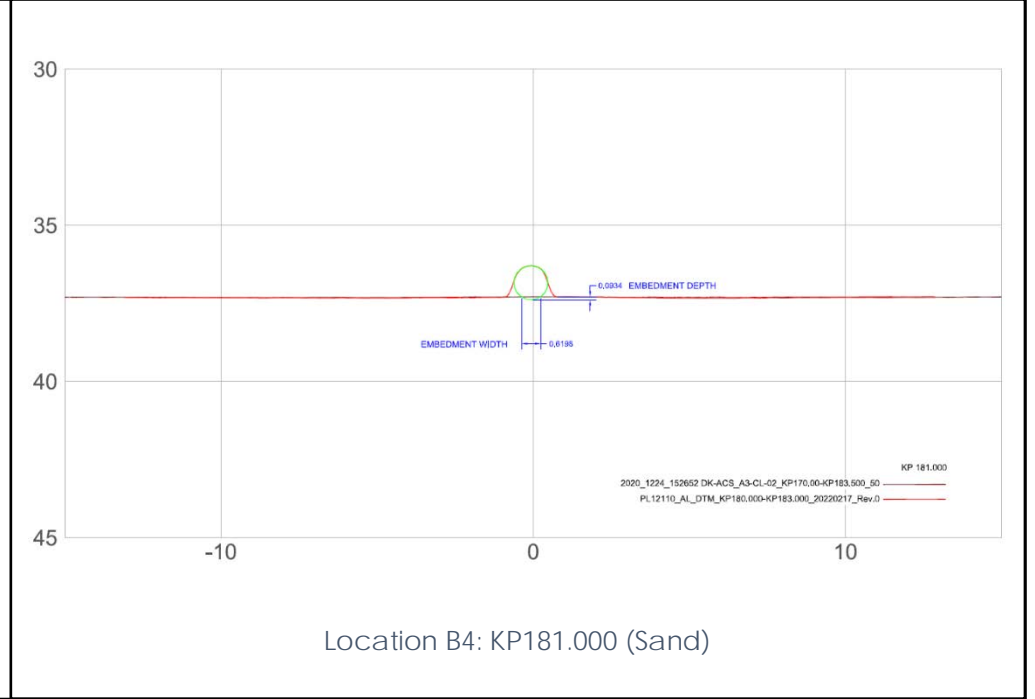
Figure 4-14: Cross-Sectional Profiles at Locations B1 – B4

No embedment is observed at the selected locations with Bedrock (Location B1) and Hard Bottom (Location B2) seabed substrate types.

Minimal embedment is observed at the selected location with Sand (Location B4) seabed substrate type.

The pipeline is embedded to approximately half its diameter at the selected location with Fine Grained Sediment (Location B3) seabed substrate type.
