| SAIPEM LTD | | | | | | COMPANY ACCEPTANCE OF FINAL VERSION | | |
|---|---|---|---|---|---|--|---|---|
| ENVIRONMENTAL REPORTING: PHYSICAL LOSSES AND PHYSICAL DISTURBANCES OF THE SEABED – DENMARK | | | | | | Contractor | | |
| Area No. | Area Description | PL1-SAI-12-Z02-RA-00003-EN | | | | | | |

The purpose of this document is to present the monitoring results to the Danish Energy Agency.

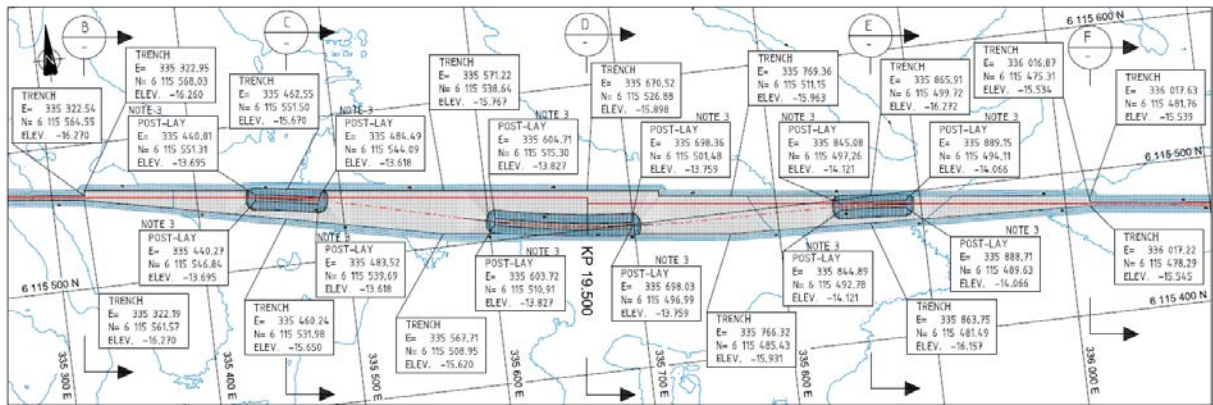
Figure 4-3: Above Water Tie-in Trench Configuration with Rock Installation Locations

Rock was installed on the pipeline at three (3) locations within the trapezoid shaped trench. During post-lay backfilling operations, the previously side cast material was returned to the trench in such a manner that the minimum backfill requirements were achieved.

The above water tie-in arrangement and approximate location of the cross sectional profile is indicated in Figure 4-3.

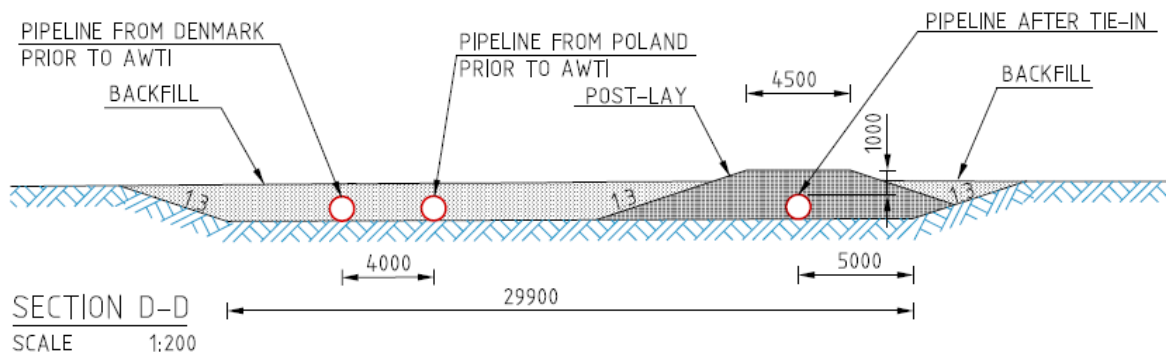
Figure 4-4: Configuration at Pipeline Above Water Tie-in

The design cross-section at this location is indicated in Figure 4-4.

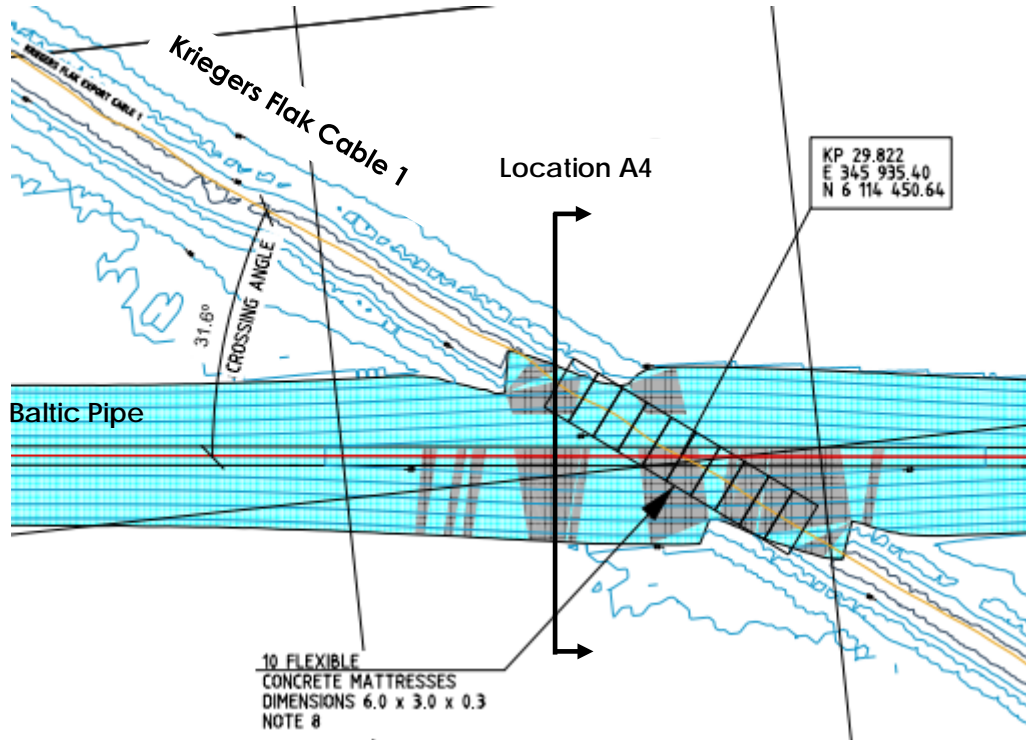
Figure 4-6: Kriegers Flak Cable Crossing

Location A4 is in the vicinity of the location where the Baltic Pipe offshore pipeline crosses the Kriegers Flak cable. The crossing arrangement and approximate location of the cross sectional profile is indicated in Figure 4-6.

Prior to pipeline installation, concrete mattresses and a pre-lay rock carpet were installed over the existing asset – which is trenched and buried at this location. The rock was installed using a dynamically positioned fall pipe vessel (DPFPV).

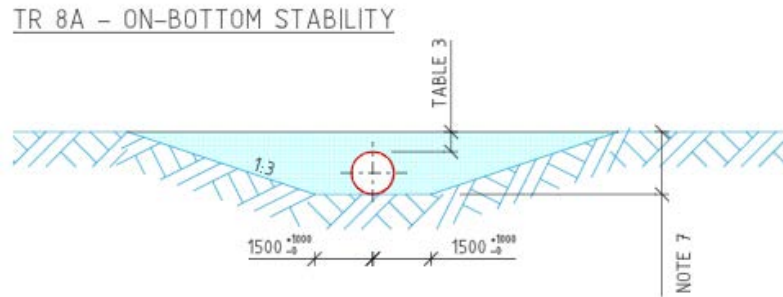
Figure 4-9: Trench Design

Location A6 is located south-west of Bornholm Island where the pipeline is installed within a trench. The trench was constructed prior to pipeline installation using primarily grab dredgers. The excavated material was side cast adjacent to the trench on the eastern side. Pipelay vessel "Castoro Sei" installed the pipeline within the trench.

During post-lay backfilling operations, the previously side cast material was returned to the trench using grab dredgers in such a manner that the minimum backfill requirements were achieved. The design configuration at this location is indicated in Figure 4-9.

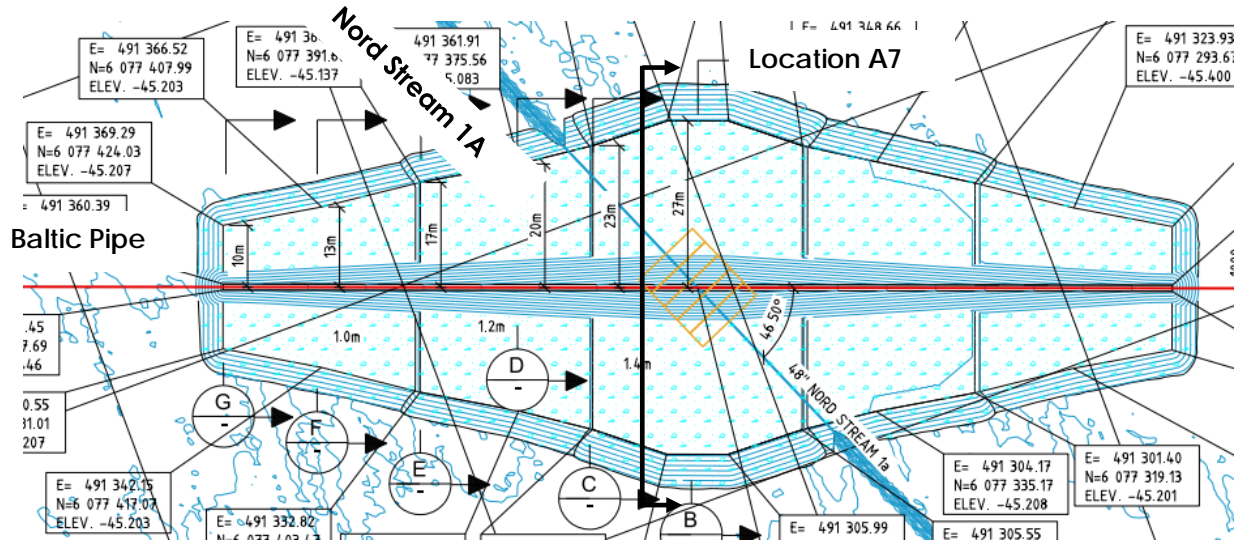
Figure 4-11: Nord Stream 1A Pipeline Crossing

Location A4 is in the vicinity of the location where the Baltic Pipe offshore pipeline crosses the Nord Stream 1A pipeline. The crossing arrangement and approximate location of the cross sectional profile is indicated in Figure 4-11.

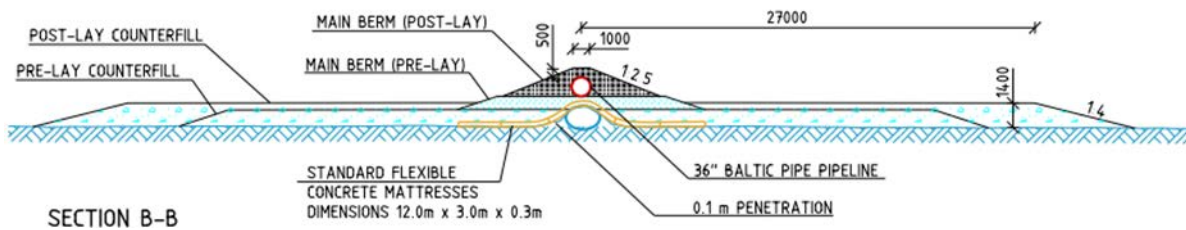
Figure 4-12: Nord Stream 1A Crossing Design

The design cross-section is indicated in Figure 4-12.

Prior to pipeline installation, concrete mattresses and a pre-lay rock carpet were installed over the Nord Stream 1A pipeline. The rock was installed using a dynamically positioned fall pipe vessel (DPFPV). The concrete mattresses and rock carpet provide protection to the pipelines during pipeline installation and operation. Following installation of the pipeline, post-lay rock installation was undertaken using DPFPV. The rock encompasses the concrete mattresses and both pipelines at this location.
